Technical Note N-1148

AIRFIELD PAVEMENT CONDITION SURVEY,  
USNAS POINT MUGU, CALIFORNIA

D. J. Lambiotte and R. B. Brownie

February 1971

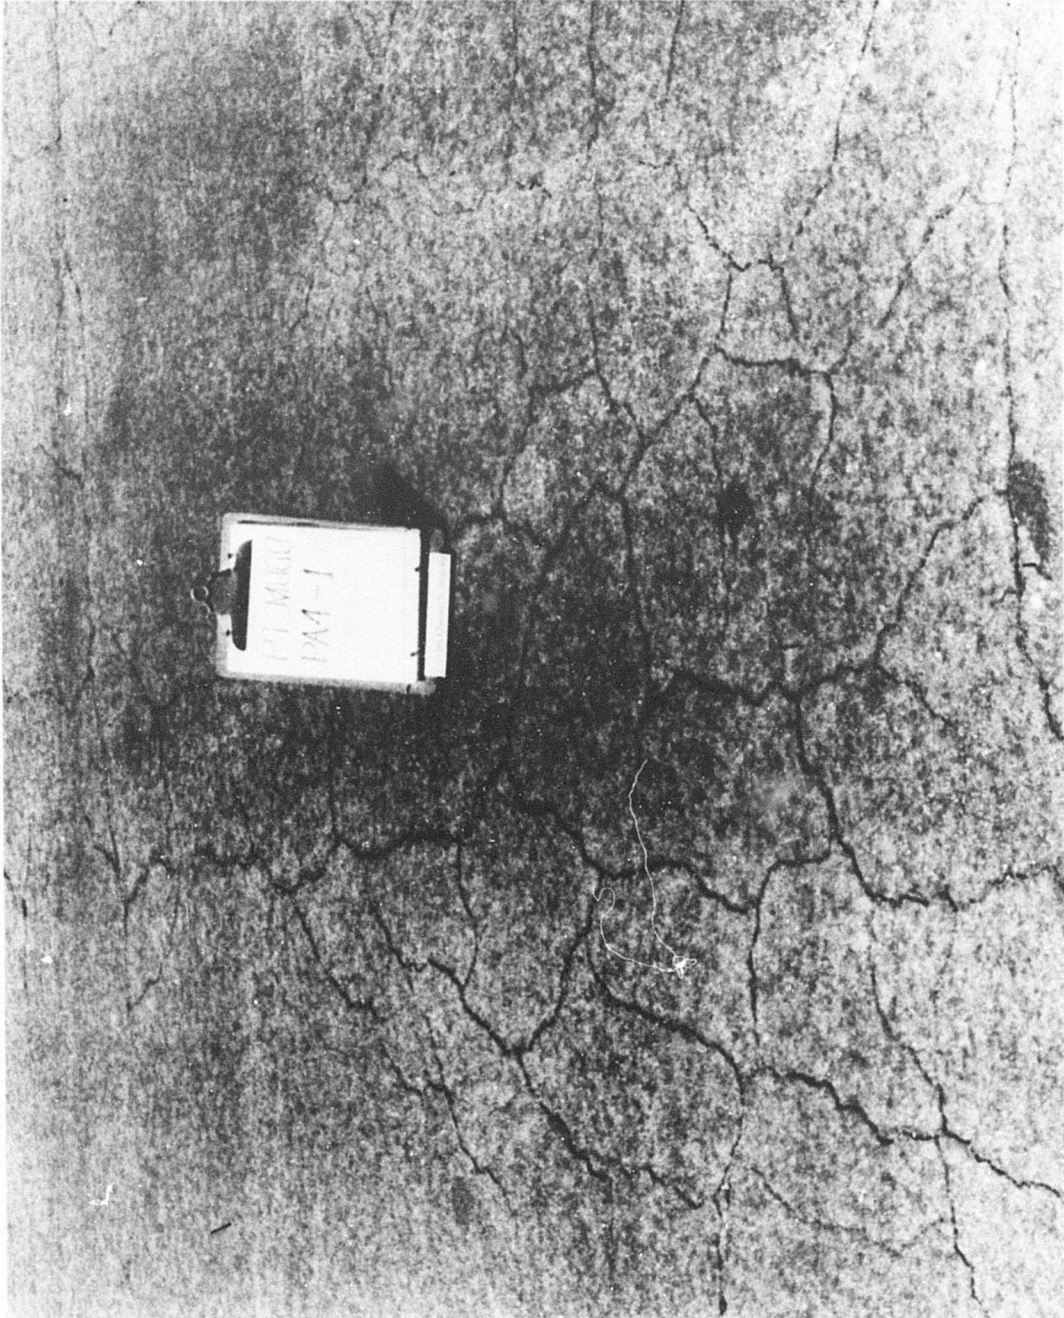
Figure 19. Severe pattern cracking, discrete area PA4-1.

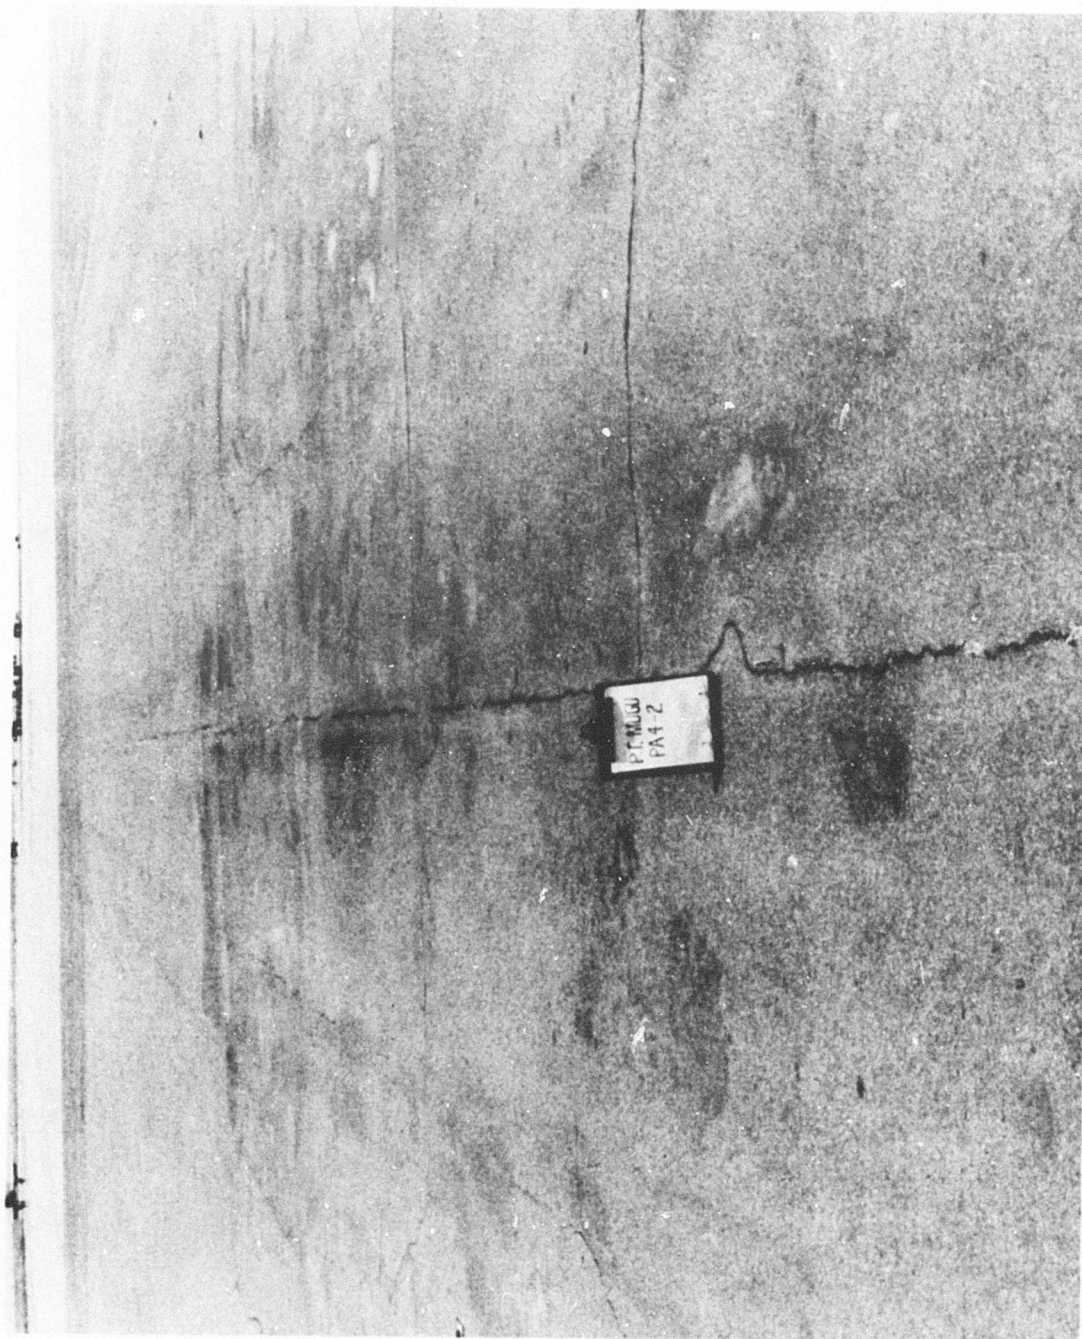
Figure 20. Unsealed longitudinal and transverse cracks, discrete area PA4-2.

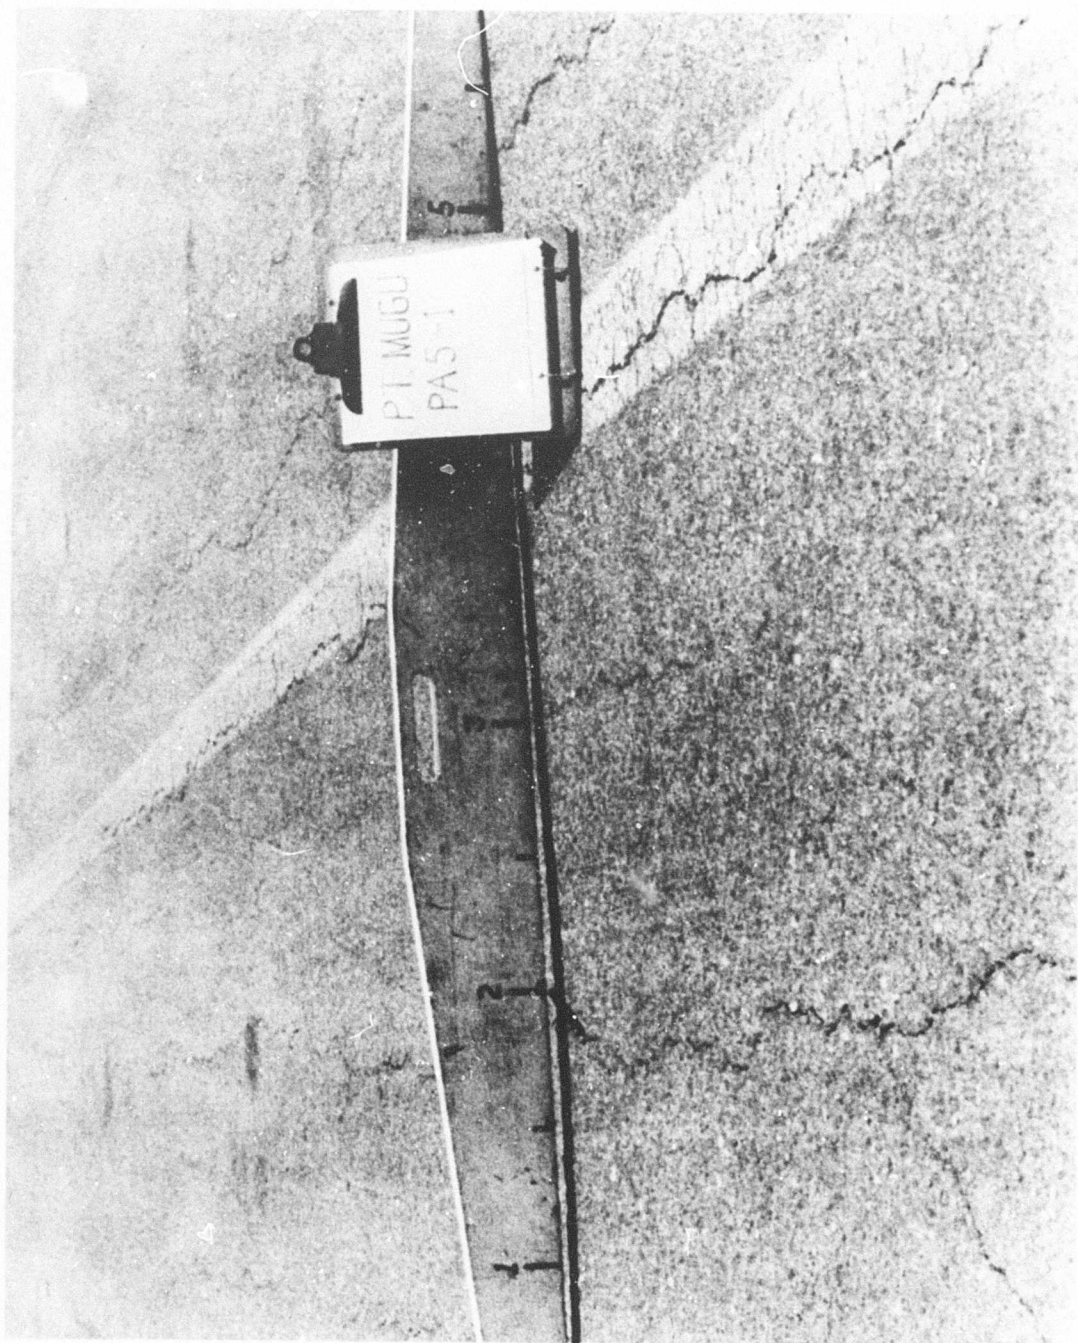
Figure 21. Rutting and pattern cracking, discrete area PA5-1.

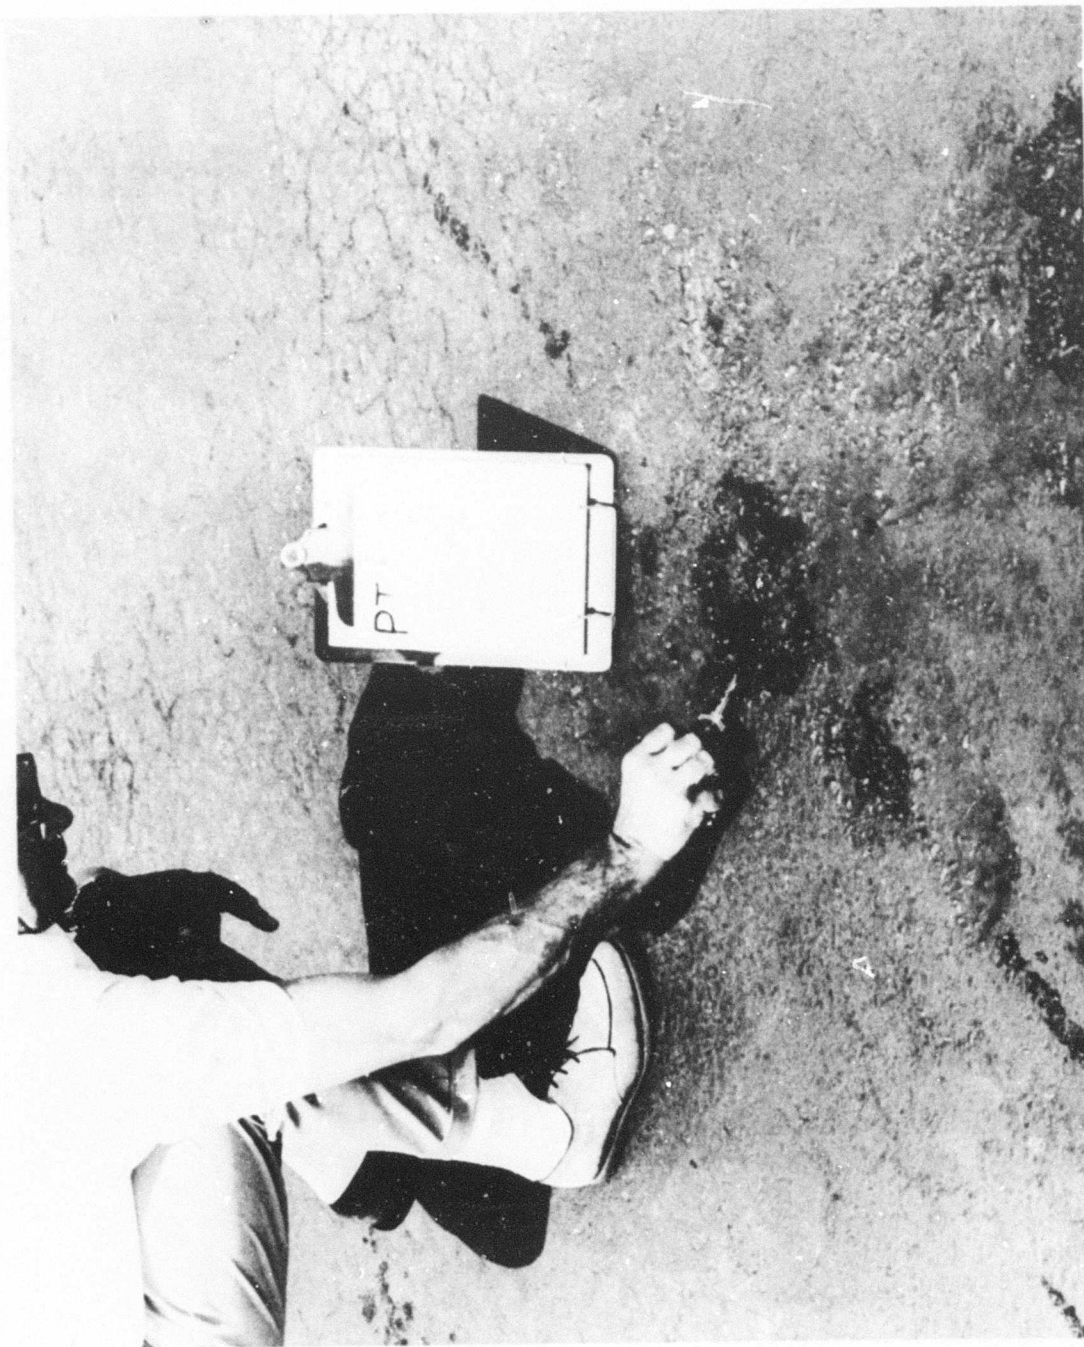
Figure 22. Surface softened by fuel or oil spillage, discrete area PA6-2.

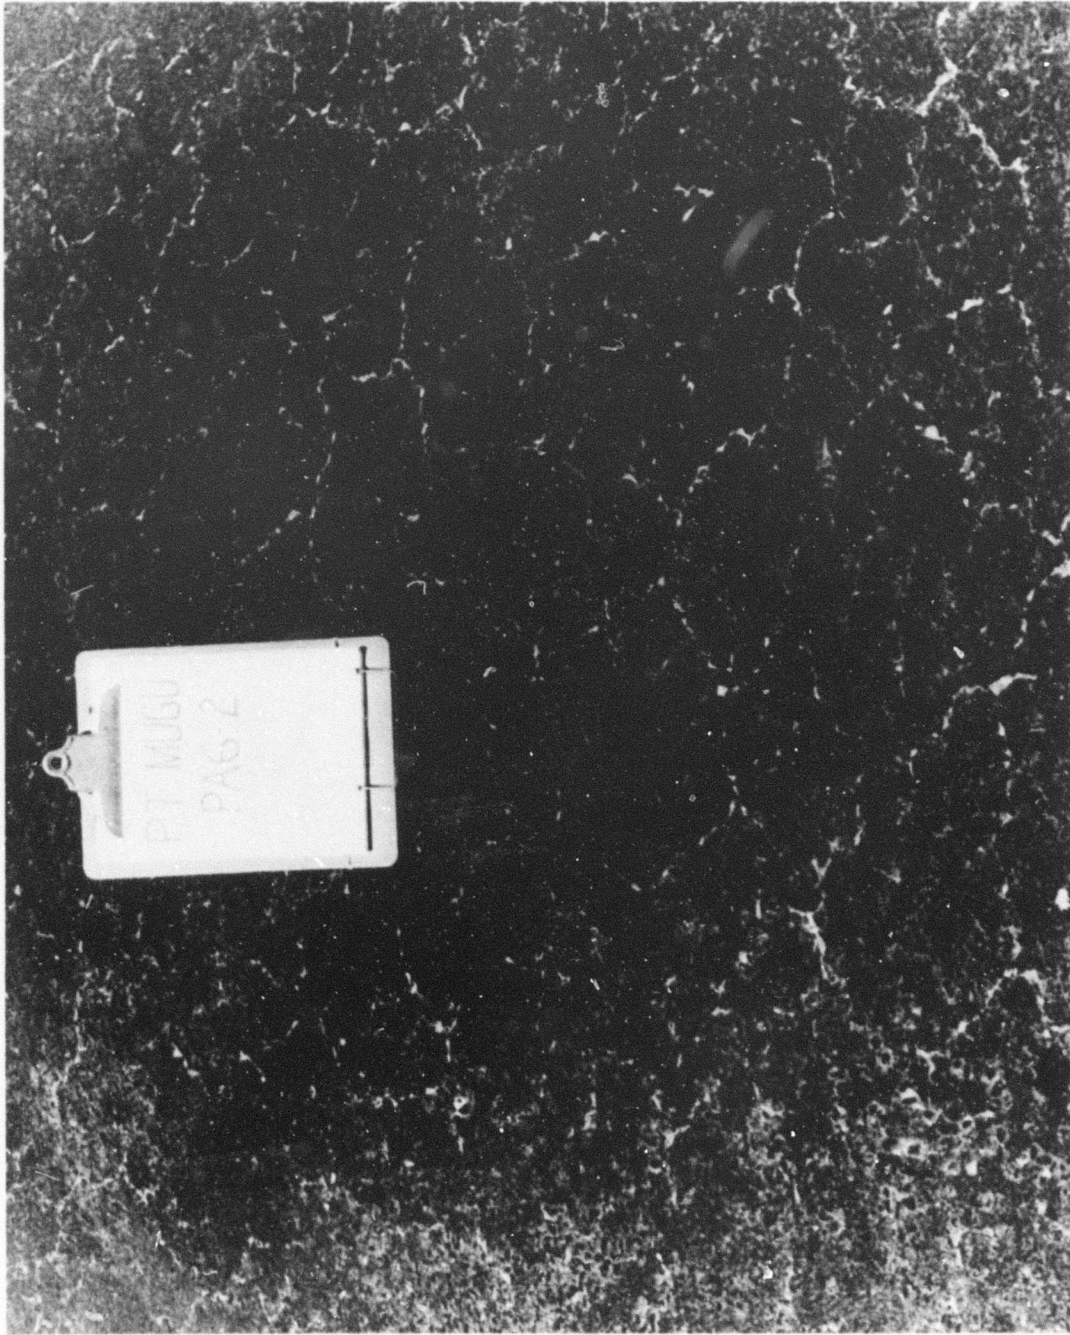
Figure 23. Pattern cracking, discrete area PA6-2.
